RESTORATION OF THE WHITE HOUSE

MESSAGE OF THE PRESIDENT OF THE UNITED STATES TRANSMITTING THE REPORT OF THE ARCHITECTS.

WASHINGTON:
GOVERNMENT PRINTING OFFICE.
1903.

REPORT OF MESSRS. McKIM, MEAD & WHITE, ARCHITECTS.

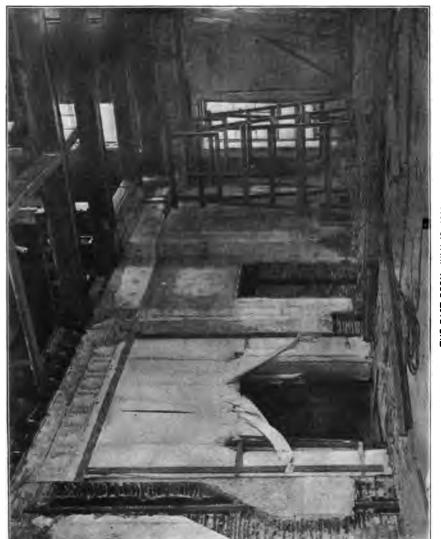
THE EAST ROOM, JULY 15, 1902.

Of the floors of the first story those under the main hall, the private dining room, and pantry, were found to be in good condition. The floor under the central portion of the East Room showed marked settlement, due to over-loading and to hanging heating coils to the ceiling underneath. The base of the room gave evidence of the settlement of the floor, and the same was true in the Green and the Blue rooms. The floor of the State Dining Room, while not showing settlement, was so insufficiently supported as to cause the dishes on the sideboards to rattle when the waiters were serving, and the plastering below was badly cracked from excessive vibration.

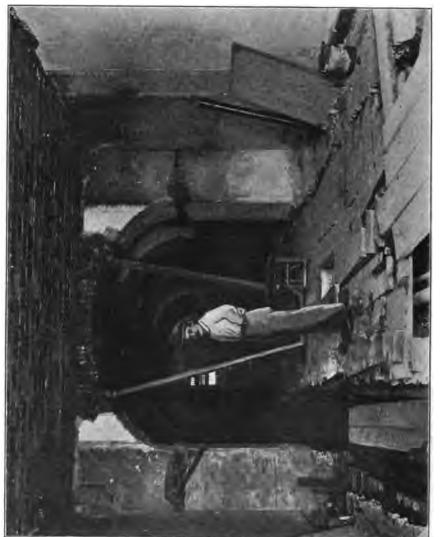
BASEMENT CORRIDOR, EAST END, JULY 15, 1902.

The heating chamber, which contained the coils of the heating apparatus, had been built into the main corridor. The fresh-air duct and the heat mains were suspended from the corridor ceiling, the masonry arches having been cut away in consequence. The whole ground floor was in bad condition; there was about it a general air of dilapidation, and the woodwork particularly was out of repair.

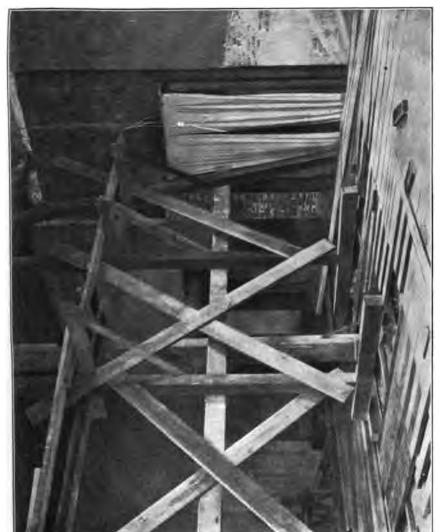
SOUTH PORTICO, MOSAIC FLOOR, BEFORE ALTERATION.

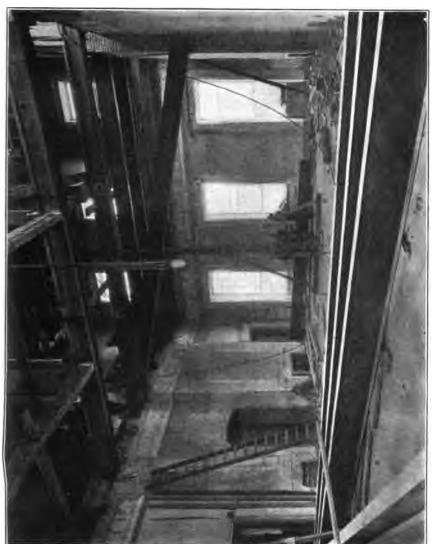
THE EAST ROOM, JULY 17, 1902.

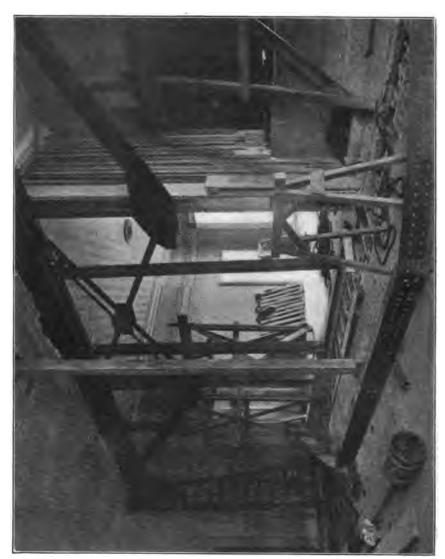
MAIN CORRIDOR, FAMILY FLOOR, OVER STATE DINING ROOM, JULY 20, 1902.

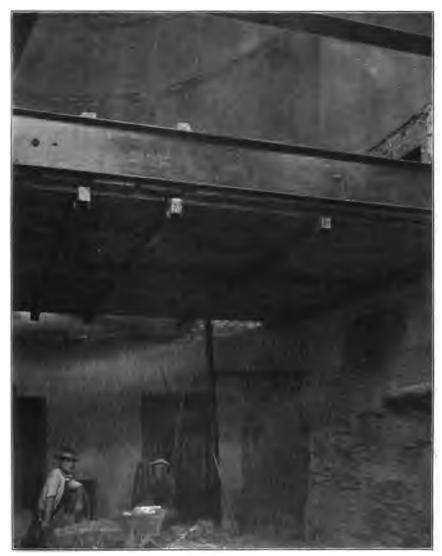
UNDER THE BLUE ROOM, JULY 20, 1902.

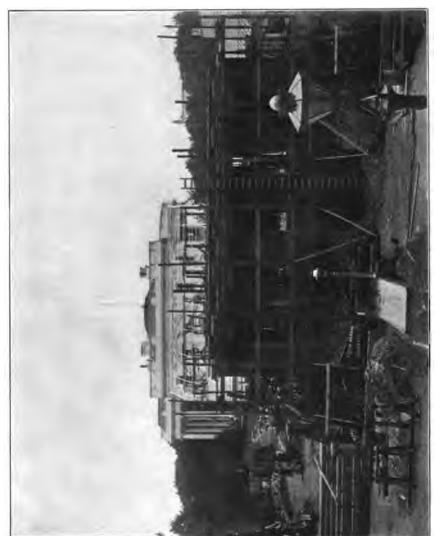
SHOWING FORMER ALTERATION IN WEST WINDOWS OF STATE DINING ROOM, AUGUST 1, 1902.

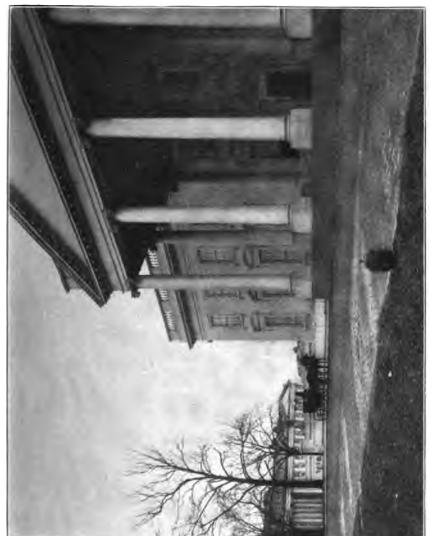
NORTH PORTICO, SHOWING LANTERN.

The old iron balustrade has been removed from the north front of the White House, and has been replaced by a stone balustrade. The lanterns which disfigured the great columns of the north portico have been removed, and that portico is now lighted by a single bronze lantern suspended from the roof of the portico.

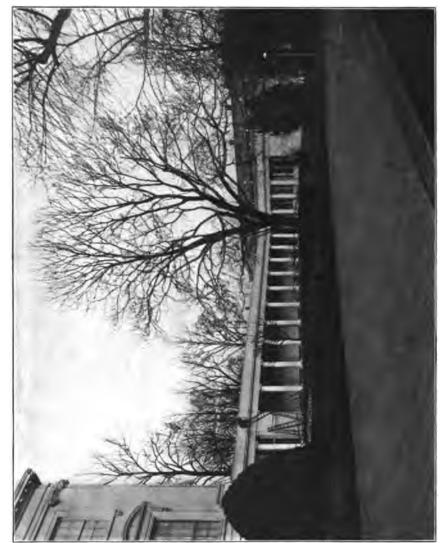
EAST TERRACE, RECONSTRUCTED ON FOUNDATION OF FORMER TERRACE.

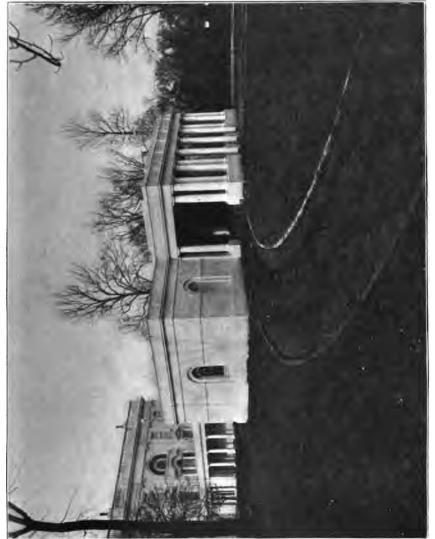
EAST TERRACE, SHOWING WATCHMEN'S QUARTERS.

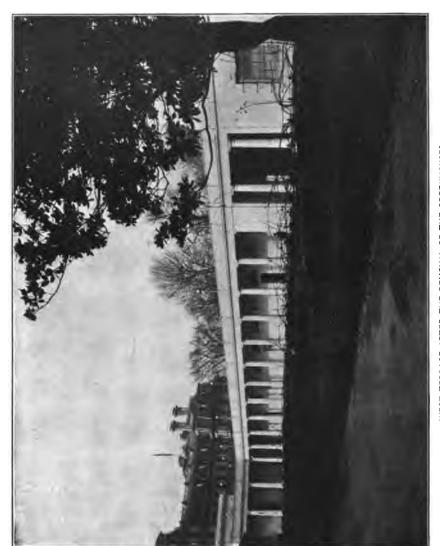
WEST TERRACE AFTER THE REMOVAL OF THE GREENHOUSES.
